8.0 Gunnison, Colorado, Disposal Site

8.1 Compliance Summary

The site, located southeast of Gunnison, Colorado, was inspected on September 3 and 4, 2003. Results of the inspection are described below. Features and photograph locations (PLs) mentioned in this report are shown on Figure 8-1. Numbers in the left margin of this report refer to items summarized in the Executive Summary table.

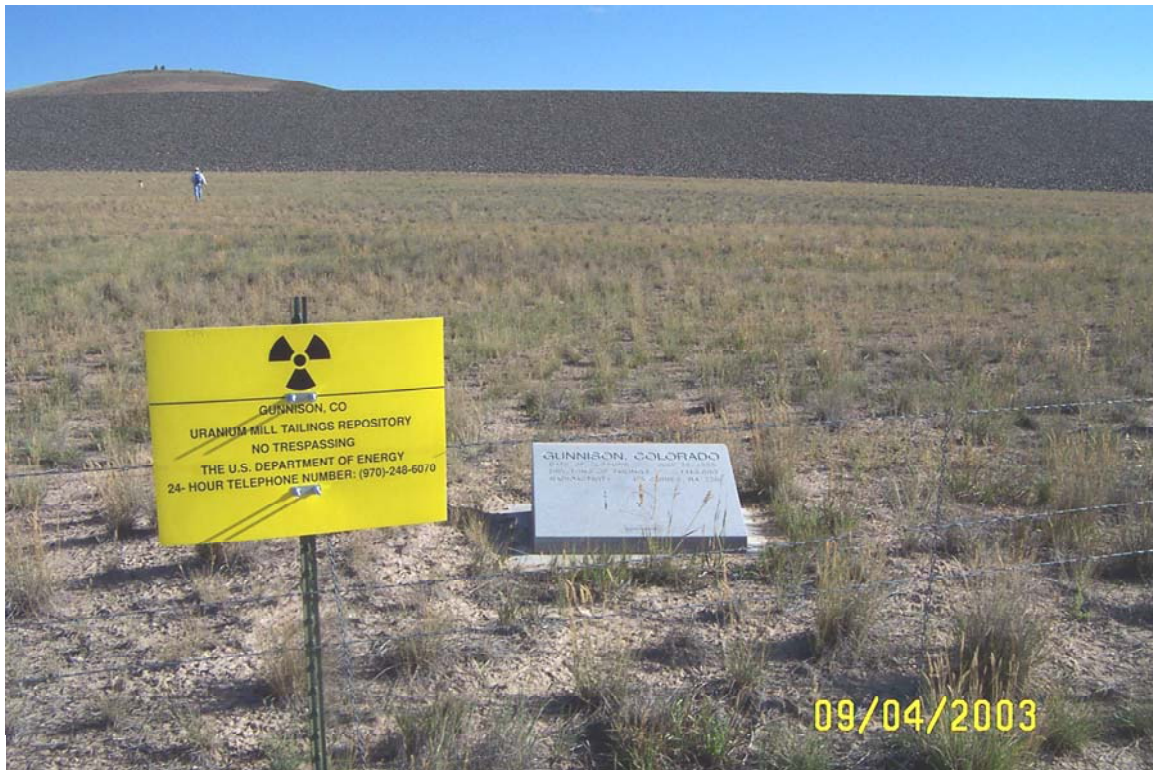
8A An entrance sign and 45 perimeter signs are attached to the posts of the perimeter fence. The entrance sign, just east of the entrance gate, was replaced with a new sign (PL-1); the former sign identified DOE-Albuquerque as the owner. Perimeter sign P1 was missing and was replaced. Perimeter sign P37 is bent and has cracked paint, but was still legible. Perimeter signs P38, P39, P42, and P44 have bullet holes in them, but all were still legible. The other perimeter signs were in excellent condition.

GUN 9/2003. PL-1. Site marker SMK-1 and the new entrance sign.

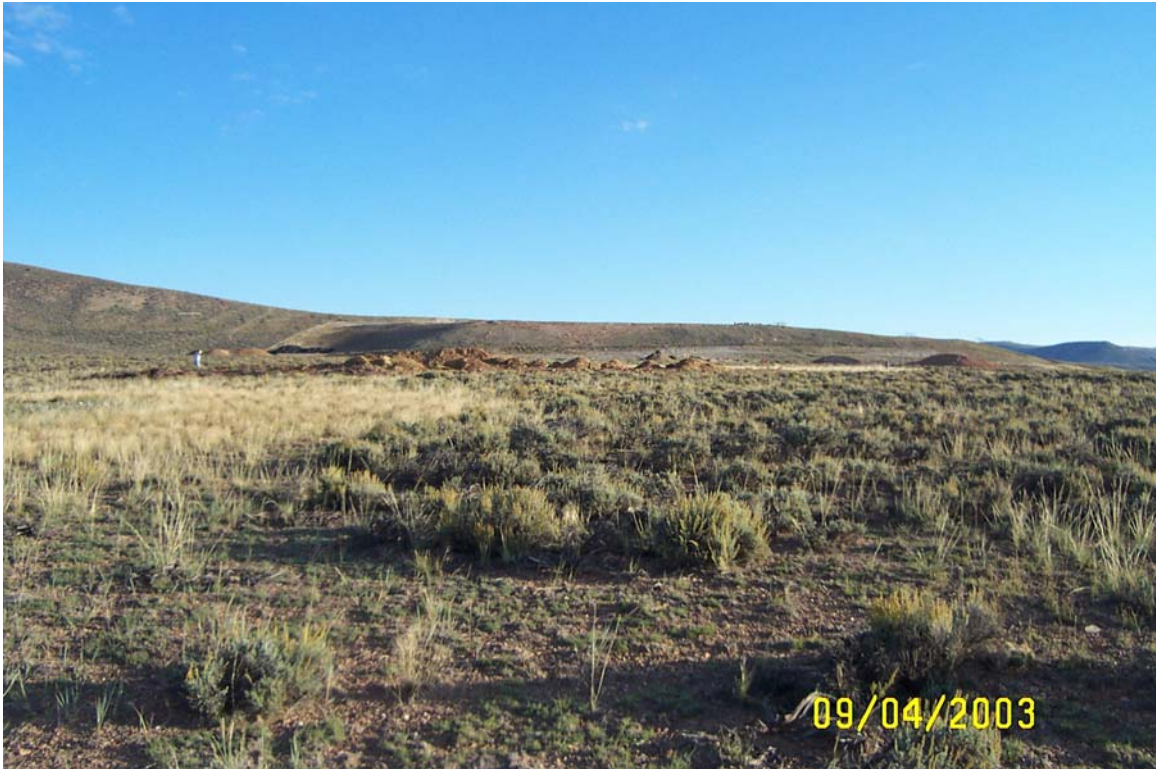
Landfill operations have encroached to within approximately 400 feet of the northeast corner of the DOE property boundary. Dirt and woodchips are piled at that location (PL-2), and trenching and filling activities are occurring immediately north of the piles. Although this activity does not appear to pose a threat to the disposal site, DOE will continue to monitor the level of activity occurring near the site property boundaries and its outlying monitor wells.

GUN 9/2003. PL-2. County landfill dirt and woodchip piles near the northeast corner of the disposal site.
